# approach

THE NAVAL AVIATION SAFETY REVIEW

*vol 5 #8*

EMERGENCY  
**LANDINGS**  
ON FOAMED  
**RUNWAYS**

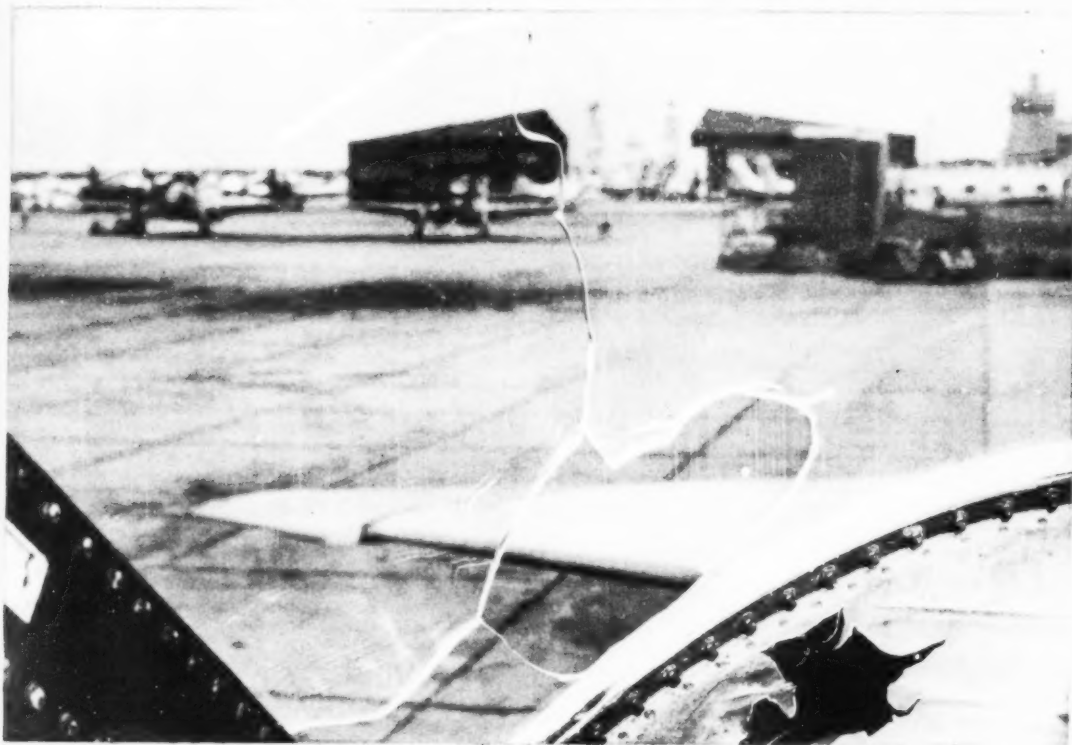
# MURPHY'S LAW\*

**A**N ordnance crew upon de-arming the seat of an F8U-1 failed to check the actual position of the safety pin. They checked the pin and red flag for position, but failed to note that the pin was around the firing mechanism instead of through the hole provided. In unhooking the connecting cable leading from the face curtain drum to the jack shaft pulley the initiator fired. Firing mechanism and canopy actuator fired through the canopy.

A ferry pilot, in attempting to place canopy safety pin in position, had put the pin around initiator head instead of through the safety pin hole.
